**Flood Control Project Maintenance
Levee Inspections**

Fall 2016 Levee Maintenance Deficiency Summary Report

Reclamation District No. 0070 Meridian

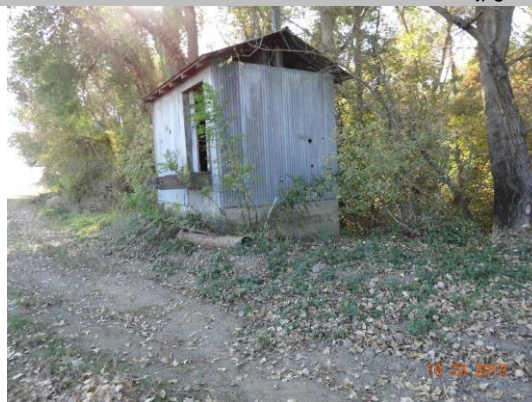
Photo 2 of 2 : UCIP_FA_2016_24190_42668.jpg

FS_ID:24190
DS_ID:21388
EP_NO: 10008
Repair Type: Non-Urgent
Crossing Status: Found
UCIP Comments: Concrete distribution box is damage on waterward side. Need to contact owner to determine status of crossing. If crossing is no longer in use owner will need to coordinate with DWR inspector and CVFPB to remove according to Title 23 requirements. This crossing is referenced in the USACE Periodic Inspection as item USACE_CESPK_MRD2_2012_p_0380.
FIELD_STRUCT_DESC: *ABANDONED* 18-inch steel pipe through the levee, 15.0 feet below the crown. Pump in pump house and slide gate on the waterward side. (USACE-1953). This entry matches the Drainage or Irrigation Structure referenced in O&M manual (Station 694+85). Concrete distribution box on landward side. This pipe was retained under ABO No. 10008 (1974). During field verification additional appurtenances were observed. An additional pipe on landward side drains into concrete distribution box. The concrete box connects to a second set of distribution boxes through a 24-inch concrete pipe approximately 36 feet upstream of crossing. Those boxes have a 10-inch pipe that appears to go through levee.

Pump house located on waterward side.

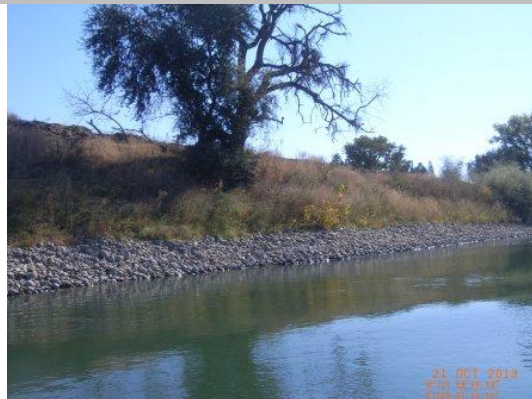
Photo 1 of 1 : FA_2016_RD0070_30_2_20160823_00002.jpg

LM Start	8.10	Rating **	M	Issue No.	2
LM End	8.23	Issue Type +	Ma	Location *	WS
Category	Supplemental			GPS Latitude/Longitude	
				Start	End
Item	2015 USACE Erosion Survey, DRAFT			39.122459 °	39.120684 °
				-121.910121 °	-121.909152 °
DWR ID	DWR_RD0070_02_s_2016_2				
Comment Code					
Inspector Comment					
1997 - Critical Site - Erosion of cobble site on outside of a bend. Failure caused by erosion of a material from behind the cobbles and cobbles rolling down the slope. Failure is just above the toe levee. Some repairs had been done at the upstream end. 2004 - Some minor new erosion at the top of the berm. 2005 - Trees look okay and the downstream end has some new rock repair. Site is no longer critical. 2006 - No longer critical, some repairs. 2015: No observed changes. [2015 Site ID: SAC_130-0_L]

USACE 2013 Photo #1

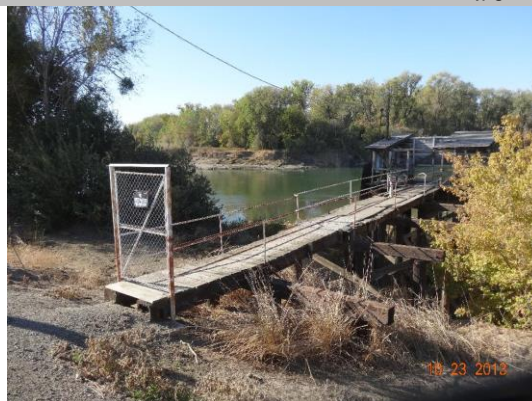
Photo 1 of 2 : UCIP_FA_2016_24108_42463.jpg

FS_ID:24108
DS_ID:21423
EP_NO: 9971
Repair Type: Non-Urgent
Crossing Status: Found
UCIP Comments: Will need to contact owner. Need to obtain maintenance records and clarify modifications made to crossing (size). This crossing is referenced in the USACE Periodic Inspection as item USACE_CESPK_MRD2_2012_p_0433.
FIELD_STRUCT_DESC: [Meridian Farms Water Com. Pumping Plant No. 3] 2 of 3: 16-inch pipe (not a 30-inch pipe as mentioned in desk study) through the levee, 20.5 feet below the crown. Gate valve on the waterward end. Pump on pile structure in stream. Wooden walkway to pump. Concrete distribution box on landward side. This pipe was retained under ABO No. 9971 (1974). Pumping plant is to be demolished under Permit No. 18762 (2013).
FS Date: 10/23/2013

View of landward side--pump station and walkway

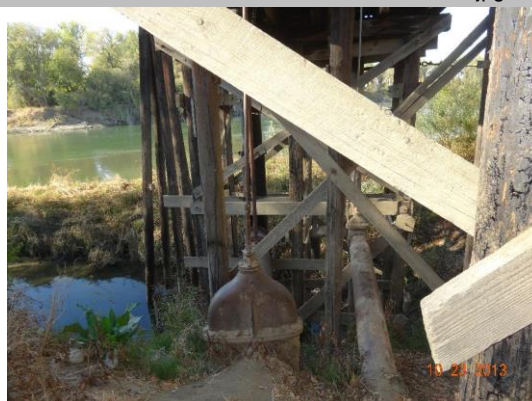
Photo 2 of 2 : UCIP_FA_2016_24108_42465.jpg

View of 16-inch pipe and 24-inch pipe with screw gate located on waterward side.

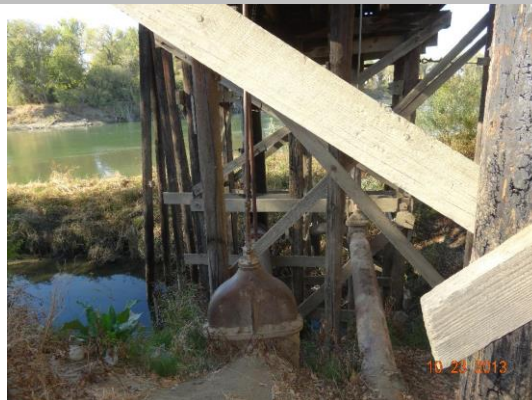
Photo 2 of 2 : UCIP_FA_2016_24107_42458.jpg

FS_ID:24107
DS_ID:21394
EP_NO: N/A
Repair Type: Non-Urgent
Crossing Status: Found
UCIP Comments: This pump station is to be demolished. This crossing will need to be updated once the work has been completed. This crossing is referenced in the USACE Periodic Inspection as item USACE_CESPK_MRD2_2012_p_0433.
FIELD_STRUCT_DESC: [Meridian Farms Water Com. Pumping Plant No. 3] 3 of 3: 24-inch pipe through the levee, 20.5 feet below the crown. Gate valve on the waterward end. Pump on pile structure in stream. Wooden walkway to pump. Concrete distribution box on landward side. Pumping plant is to be demolished under Permit No. 18762 (2013).
FS Date: 10/23/2013

View of 16-inch pipe and 24-inch pipe through levee on waterward side.

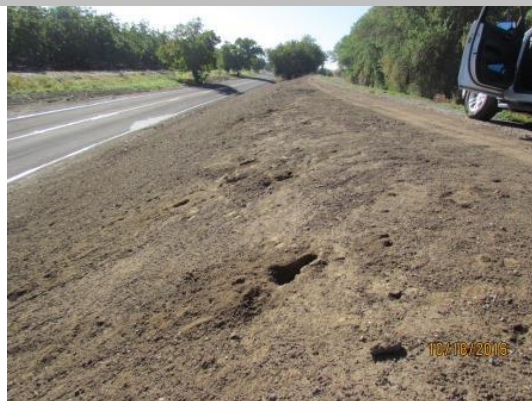
Photo 1 of 1 : FA_2016_RD0070_30_61_20161028_00115.jpg

LM Start	9.28	Rating **	M	Issue No.	61
LM End	9.28	Issue Type +	Ma	Location *	LS
Category	Earthen Levee			GPS Latitude/Longitude	
				Start	End
Item	Animal Control			39.107285 °	39.107285 °
				-121.900753 °	-121.900753 °
DWR ID	DWR_RD0070_02_f_2016_61				
Comment Code					
A3 : No rodents visible, but rodent burrows visible; need to backfill and compact or grout burrows.					
Inspector Comment

View of the rodent holes along the landside slope.

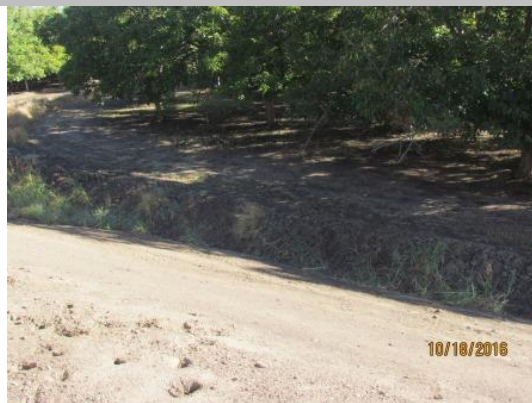
Photo 1 of 1 : FA_2016_RD0070_30_62_20161028_00116.jpg

LM Start	9.57	Rating **	U	Issue No.	62
LM End	9.70	Issue Type +	En	Location *	LS
Category	Earthen Levee			GPS Latitude/Longitude	
				Start	End
Item	Encroachments			39.103192 °	39.101213 °
				-121.899606 °	-121.899380 °
DWR ID	DWR_RD0070_02_f_2016_62				
Comment Code					
DT : Ditch					
Inspector Comment

View of a ditch along the landside toe.

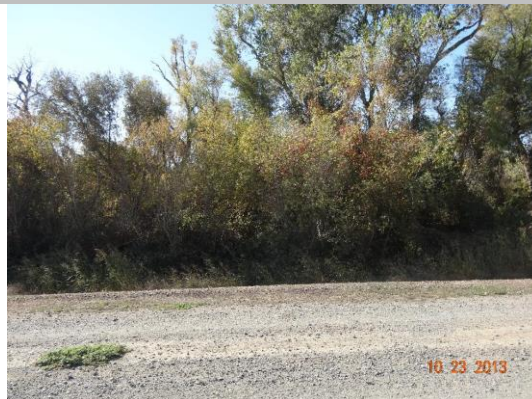
Photo 1 of 2 : UCIP_FA_2016_23967_42129.jpg

FS_ID:23967
DS_ID:21396
EP_NO: N/A
Repair Type: Non-Urgent
Crossing Status: Indicator Found
UCIP Comments: No evidence of pipe is visible on waterward side. Need to coordinate with owner to determine status of crossing. If crossing is no longer in use owner will need to contact the CVFPB to comply with Title 23. This crossing is referenced in the USACE Periodic Inspection as item USACE_CESPK_MRD2_2012_p_0477.
FIELD_STRUCT_DESC: *ABANDONED* 12-inch pipe through the levee, 3.1 feet below the crown. Siphon breaker in CM pipe riser on landward shoulder. Concrete plug at landward end. Wood distribution box on landward side at discharge end. (USACE-1953). This entry matches the Drainage or Irrigation Structure referenced in O&M manual (Station 813+00). (Cat. IV-A)
FS Date: 10/23/2013

View of waterward side.

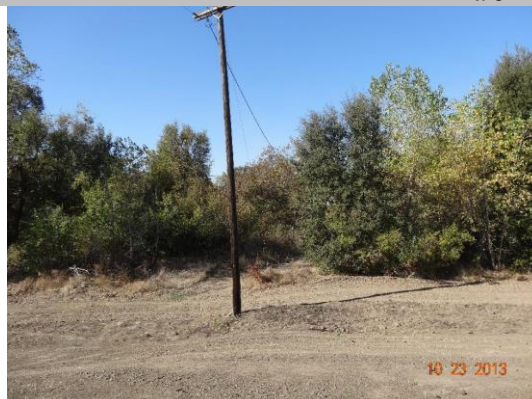
Photo 1 of 2 : UCIP_FA_2016_24195_42686.jpg

FS_ID:24195
DS_ID:21398
EP_NO: 1162
Repair Type: Non-Urgent
Crossing Status: Found
UCIP Comments: Need to verify status of crossing--variation in pipe size. 18 inch pipe listed in desk study and 20 inch pipe found in field. Damage to siphon breaker housing unit. This crossing is referenced in the USACE Periodic Inspection as item USACE_CESPK_MRD2_2012_p_0482.
FIELD_STRUCT_DESC: 1 of 2: 20-inch (not 18-inch as listed in desk study) steel pipe through the levee, 3.7 feet below the crown. Two concrete cutoff walls around pipe, at levee shoulders. Siphon breakers in steel pipe risers on landward shoulder. Slant pumps on wooden pump structure on waterward side. Two CM pipe risers under pump structure at waterward toe. Distribution box at landward toe. (Permit No. 1162-1946) This entry matches the Drainage or Irrigation Structure referenced in O&M manual (Station 824+00).
FS Date: 10/23/2013

View of waterward side pathway behind power pole leads to pump station.

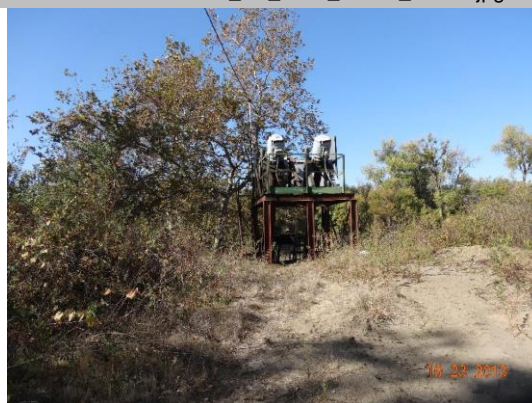
Photo 2 of 2 : UCIP_FA_2016_24195_42685.jpg

Pump station located on waterward side.

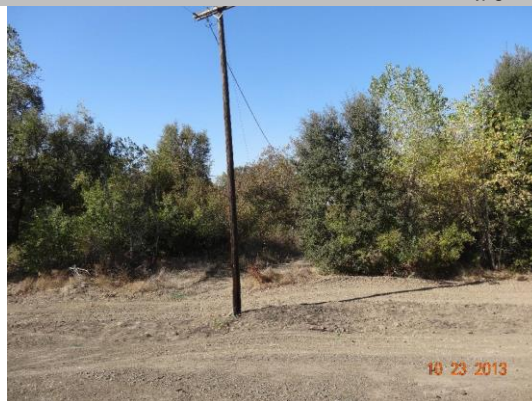
Photo 1 of 2 : UCIP_FA_2016_24196_42693.jpg

FS_ID:24196
DS_ID:21430
EP_NO: 1162
Repair Type: Non-Urgent
Crossing Status: Found
UCIP Comments: Need to verify status of crossing--variation in pipe size. 18 inch pipe listed in desk study and 20 inch pipe found in field. This crossing is referenced in the USACE Periodic Inspection as item USACE_CESPK_MRD2_2012_p_0482.
FIELD_STRUCT_DESC: 2 of 2: 20-inch (not 18-inch as listed in desk study) steel pipe through the levee, 3.7 feet below the crown. Two concrete cutoff walls around pipe, at levee shoulders. Siphon breakers in steel pipe risers on landward shoulder. Slant pumps on wooden pump structure on waterward side. Two CM pipe risers under pump structure at waterward toe. Distribution box at landward toe. (Permit No. 1162-1946) This entry matches the Drainage or Irrigation Structure referenced in O&M manual (Station 824+00).
FS Date: 10/23/2013

View of waterward side path to pump station is behind the power pole.

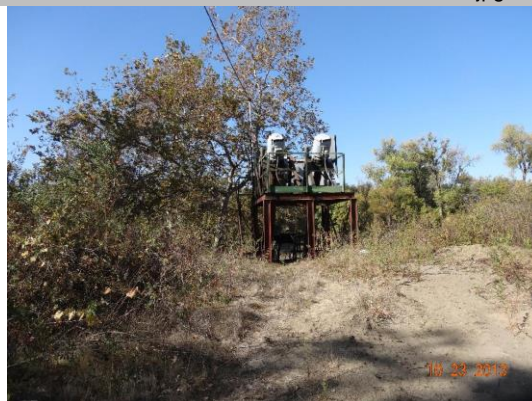
Photo 2 of 2 : UCIP_FA_2016_24196_42692.jpg

Pump station on waterward side dense vegetation on slope.

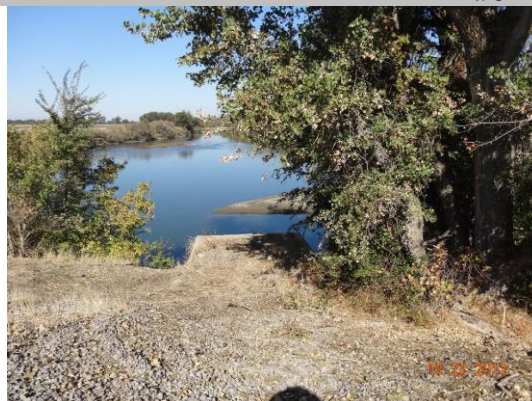
Photo 1 of 2 : UCIP_FA_2016_24197_42699.jpg

Comment Code					
Inspector Comment					
FS_ID:24197 DS_ID:21400 EP_NO: 9986 Repair Type: Non-Urgent Crossing Status: Indicator Found UCIP Comments: Need to coordinate with owner to determine status of crossing. If crossing is no longer in use owner will need to contact the CVFPB to comply with Title 23. This crossing is referenced in the USACE Periodic Inspection as item USACE_CESPK_MRD2_2012_p_0527. FIELD_STRUCT_DESC: 30-inch steel pipe through the levee, 27.5 feet below the crown. Two electric gate valves in concrete pit on waterward end at end of discharge pipe. Two slant pumps on waterward slope. Control switches in CM shed at waterward shoulder. (USACE-1953). This entry matches the Drainage or Irrigation Structure referenced in O&M manual (Station 889+72). This pipe was retained under ABO No. 9986 (1974). One pump and one gate valve installed under Permit No. 5193 (1966). This pumping plant was demolished with pipes grouted and abandoned under Permit No. 18323 (2009). FS Date: 10/23/2013

View of waterward side.

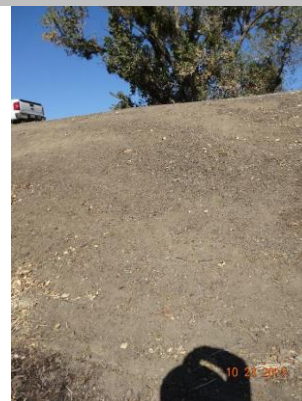
Photo 2 of 2 : UCIP_FA_2016_24197_42698.jpg

Item	DWR UCIP Field Study		39.080517 °	39.080517 °								
			-121.890574 °	-121.890574 °								
DWR ID												
Comment Code												
Inspector Comment												
FS_ID:24197 DS_ID:21400 EP_NO: 9986 Repair Type: Non-Urgent Crossing Status: Indicator Found UCIP Comments: Need to coordinate with owner to determine status of crossing. If crossing is no longer in use owner will need to contact the CVFPB to comply with Title 23. This crossing is referenced in the USACE Periodic Inspection as item USACE_CESPK_MRD2_2012_p_0527. FIELD_STRUCT_DESC: 30-inch steel pipe through the levee, 27.5 feet below the crown. Two electric gate valves in concrete pit on waterward end at end of discharge pipe. Two slant pumps on waterward slope. Control switches in CM shed at waterward shoulder. (USACE-1953). This entry matches the Drainage or Irrigation Structure referenced in O&M manual (Station 889+72). This pipe was retained under ABO No. 9986 (1974). One pump and one gate valve installed under Permit No. 5193 (1966). This pumping plant was demolished with pipes grouted and abandoned under Permit No. 18323 (2009). FS Date: 10/23/2013

View of landward slope.

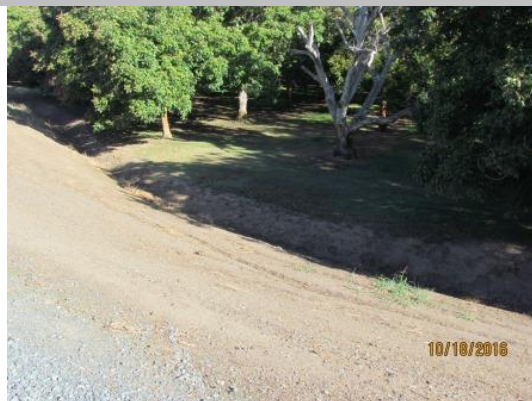
Photo 1 of 1 : FA_2016_RD0070_30_65_20161028_00117.jpg

LM Start	12.26	Rating **	M	Issue No.	65
LM End	12.26	Issue Type +	En	Location *	LS
Category	Earthen Levee			GPS Latitude/Longitude	
				Start	End
Item	Encroachments			39.073416 °	39.073416 °
				-121.889254 °	-121.889254 °
DWR ID	DWR_RD0070_02_f _ 2016_65				
Comment Code					
DT : Ditch					
Inspector Comment

View of a ditch along the landside toe.

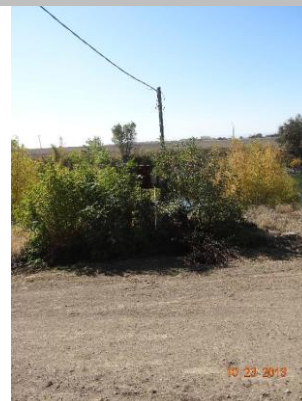
Photo 1 of 2 : UCIP_FA_2016_47033_42141.jpg

Comment Code					
Inspector Comment					
FS_ID:47033 DS_ID:21402 EP_NO: 9997 Repair Type: Non-Urgent Crossing Status: Found UCIP Comments: Debris found on waterward side along berm running parallel to levee. Two crossing found--Need to coordinate with owner to determine permit for second crossing and status of crossing. If crossing is no longer in use owner will need to contact the CVFPB to comply with Title 23. Dense vegetation limits the inspector's visibility to identify signs of pipe failure (leaks) along the waterward slope. Recommend removing vegetation along pipe alignment to conduct proper inspection of structure and appurtenances. This crossing is referenced in the USACE Periodic Inspection as item USACE_CESPK_MRD2_2012_p_0559. FIELD_STRUCT_DESC: 12-inch steel pipe through the levee, 3.5 feet below the crown. Siphon breaker in CM pipe riser on landward shoulder. Control valve and pump on waterward side. Power pole on waterward shoulder. Discharge box at landward toe. (USACE-1953). This entry matches the Drainage or Irrigation Structure referenced in O&M manual (Station 930+22). This pipe was retained under ABO No. 9997 (1974). FS Date: 10/23/2013

Crossing appurtenances located near brush and power pole on waterward side.

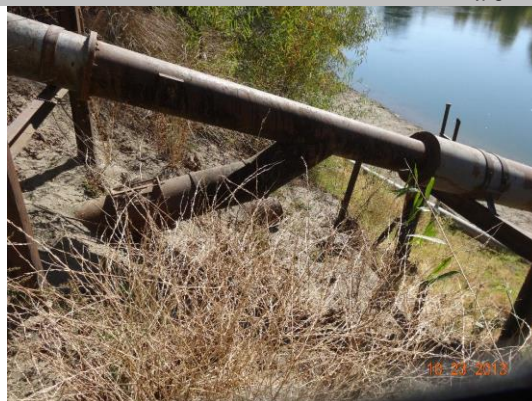
Photo 2 of 2 : UCIP_FA_2016_47033_42139.jpg

Item	DWR UCIP Field Study			39.072540 °	39.072540 °	
				-121.887807 °	-121.887807 °	
DWR ID						
Comment Code						
Inspector Comment						
FS_ID:47033 DS_ID:21402 EP_NO: 9997 Repair Type: Non-Urgent Crossing Status: Found UCIP Comments: Debris found on waterward side along berm running parallel to levee. Two crossing found--Need to coordinate with owner to determine permit for second crossing and status of crossing. If crossing is no longer in use owner will need to contact the CVFPB to comply with Title 23. Dense vegetation limits the inspector's visibility to identify signs of pipe failure (leaks) along the waterward slope. Recommend removing vegetation along pipe alignment to conduct proper inspection of structure and appurtenances. This crossing is referenced in the USACE Periodic Inspection as item USACE_CESPK_MRD2_2012_p_0559. FIELD_STRUCT_DESC: 12-inch steel pipe through the levee, 3.5 feet below the crown. Siphon breaker in CM pipe riser on landward shoulder. Control valve and pump on waterward side. Power pole on waterward shoulder. Discharge box at landward toe. (USACE-1953). This entry matches the Drainage or Irrigation Structure referenced in O&M manual (Station 930+22). This pipe was retained under ABO No. 9997 (1974). FS Date: 10/23/2013

Pipe crossing on waterward side. Second pipe comes out approximately 3 feet downstream from this crossing.

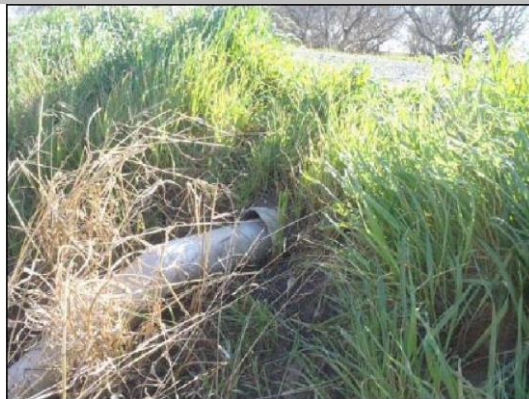
Photo 1 of 2 : UCIP_FA_2016_50086_42883.jpg

FS_ID:50086
DS_ID:24744
EP_NO: N/A
Repair Type: Non-Urgent
Crossing Status: Found
UCIP Comments: 07/07/2016 Dense vegetation on both slopes. No damage was observed on levee slopes or crown, crossing was downgraded from Urgent to Non-Urgent. No permit found for crossing. Need to recheck during winter. According to Andy Duffey, District Representative, CVFPB has issued an enforcement letter to owner dated 6/23/2016. (DWR UCIP - omagana)10/23/2013 No records were found during initial desk study--need to contact owner to obtain permit number authorizing work. Owner will need to coordinate with DWR Inspector and CVFPB to remove crossing according to Title 23 requirements. (DWR UCIP - omagana)
FIELD_STRUCT_DESC: 6-inch aluminum irrigation pipe sleeved through a 10-inch corrugated metal pipe (annular space not grouted) through the levee, 1.5 feet below the crown. Pipe extends down both slopes about 2 feet below crown.

View of pipe through levee--photo is from USACE PI Draft Report dated 6-2012.

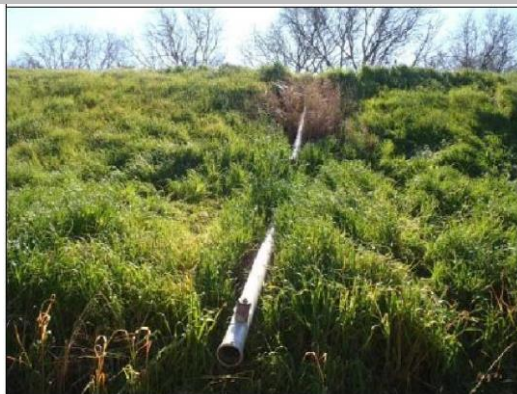
Photo 2 of 2 : UCIP_FA_2016_50086_42882.jpg

View of pipe through levee--photo is from USACE PI Draft Report dated 6-2012.

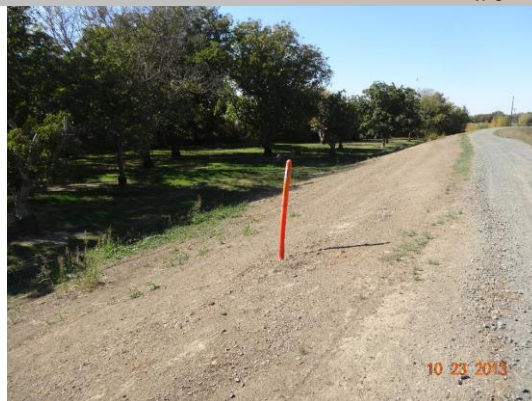
Photo 1 of 2 : UCIP_FA_2016_23984_42172.jpg

Comment Code					
Inspector Comment					
FS_ID:23984 DS_ID:21403 EP_NO: 3800 Repair Type: Non-Urgent Crossing Status: Indicator Found UCIP Comments: Need to contact owner to determine if crossing is still active and to determine last inspection date. Will need copy of letter showing crossings passed inspection. This crossing is referenced in the USACE Periodic Inspection as item USACE_CESPK_MRD2_2012_p_0568. FIELD_STRUCT_DESC: 20-inch steel gas pipe through the levee, 3.0 feet below the crown. Concrete cutoff wall around pipe at center of levee. Marker sign on waterward shoulder. Natural gas equipment pad at landward toe. (Permit No. 3800-1962) FS Date: 10/23/2013

Marker located on waterward side.

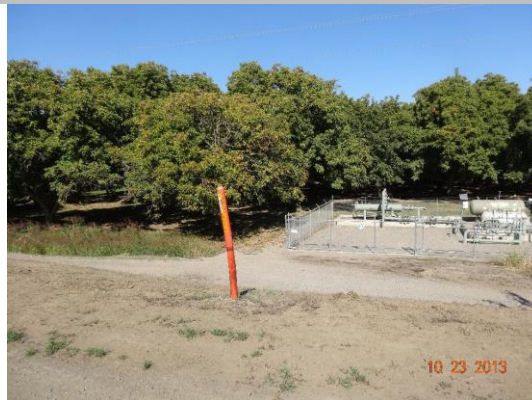
Photo 2 of 2 : UCIP_FA_2016_23984_42171.jpg

Marker on landward side.

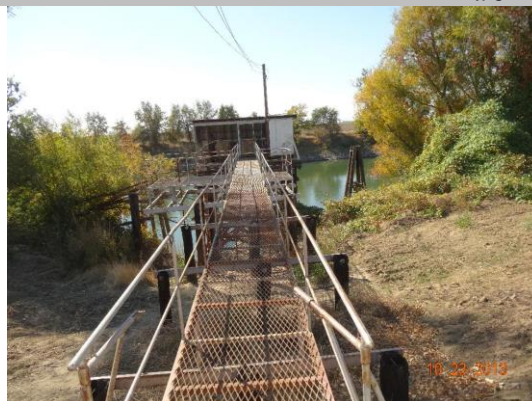
Photo 1 of 2 : UCIP_FA_2016_24229_42848.jpg

FS_ID:24229
DS_ID:21421
EP_NO: 9990
Repair Type: Non-Urgent
Crossing Status: Found
UCIP Comments: Need to determine if crossings are still being used. This crossing is referenced in the USACE Periodic Inspection as item USACE_CESPK_MRD2_2012_p_0685.
FIELD_STRUCT_DESC: 1 of 2: 24-inch steel pipe sleeved through a 30-inch steel pipe through the levee, 24.0 feet below the crown. Gate valves on waterward end. Concrete headwall with flap gate on landward side. Pumps on pile structure in stream. Wooden walkway to pumps. (USACE-1953). This entry matches the Drainage or Irrigation Structure referenced in O&M manual (Station 1086+55). This pipe was retained under ABO No. 9990 (1974).
FS Date: 10/23/2013

Walkway and pump house on waterward side.

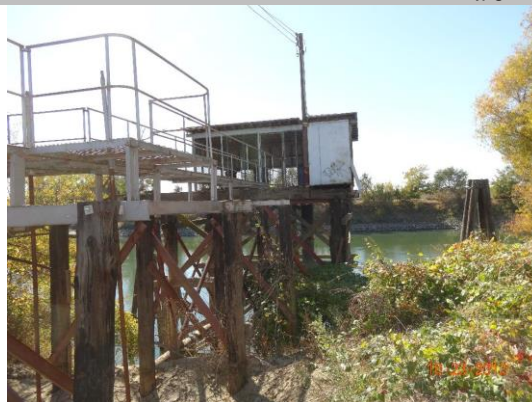
Photo 2 of 2 : UCIP_FA_2016_24229_42849.jpg

Pump house located on waterward side.

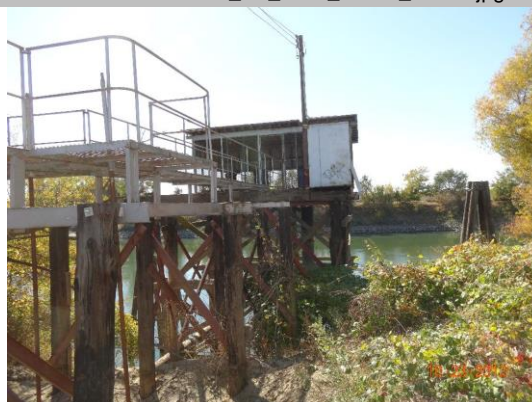
Photo 2 of 2 : UCIP_FA_2016_24230_42855.jpg

FS_ID:24230
DS_ID:21409
EP_NO: 9990
Repair Type: Non-Urgent
Crossing Status: Found
UCIP Comments: Need to determine if crossing is still being used. This crossing is referenced in the USACE Periodic Inspection as item USACE_CESPK_MRD2_2012_p_0685.
FIELD_STRUCT_DESC: 2 of 2: 24-inch steel pipe sleeved through a 30-inch steel pipe through the levee, 24.0 feet below the crown. Gate valves on waterward end. Concrete headwall with flap gate on landward side. Pumps on pile structure in stream. Wooden walkway to pumps. (USACE-1953). This entry matches the Drainage or Irrigation Structure referenced in O&M manual (Station 1086+55). This pipe was retained under ABO No. 9990 (1974).
FS Date: 10/23/2013

Pump located on waterward side.

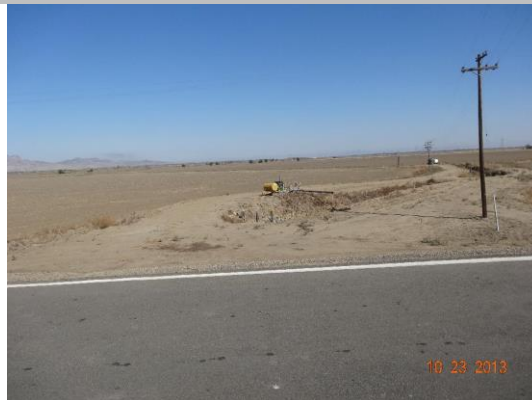
Photo 2 of 2 : UCIP_FA_2016_24231_42863.jpg

FS_ID:24231
DS_ID:21420
EP_NO: N/A
Repair Type: Non-Urgent
Crossing Status: Found
UCIP Comments: No daylight visible on landward side. Pipe was visible on waterward side. Need to contact owner to determine status of crossing. This crossing is referenced in the USACE Periodic Inspection as item USACE_CESPK_MRD2_2012_p_0685.
FIELD_STRUCT_DESC: 16-inch steel pipe through the levee, approximately 15.0 feet below the crown. Gate valves on waterward end. Pumps on waterward side. (USACE-1953). This entry matches the Drainage or Irrigation Structure referenced in O&M manual (Station 1086+55).
FS Date: 10/23/2013

View of landward side.
